GO Number	S/A Number	Page 1 of	Total Pages	Rev. Ltr/Chg. No. See Summary of Chg.	Number
97055	31170	145	145	NEW	EID-06141
Program Title Closure of ETEC (R21-RF)					
Document Title Hot Laboratory Decontamination and Dismantlement Final Report					
Document Type Engineering Information Document			Related Documents		
Original Issue Date 11/13/01		Release Date RELEASE 11/27/01 TV		Approvals Date	
Prepared By/Date D. W. Kneff D. M. Trippeda		Dept. 117 117	Mail/Addr T038 T038	R. D. Meyer	
IR&D Program? Yes <input type="checkbox"/> No <input checked="" type="checkbox"/> If Yes, Enter Authorization No.					
Distribution			Abstract

*	Name	Mail Addr.		<p>The former Rockwell International Hot Laboratory, located at Boeing Canoga Park's Santa Susana Field Laboratory in Ventura County, California, operated under Department of Energy funding from 1959 until 1987. It was used originally for the disassembly and examination of irradiated nuclear reactor fuel assemblies and test specimens, and later for the decladding of irradiated plutonium-bearing fuels from off-site reactors. Decontamination and decommissioning (D&D) of the facility was initiated in 1987, and facility dismantlement was complete

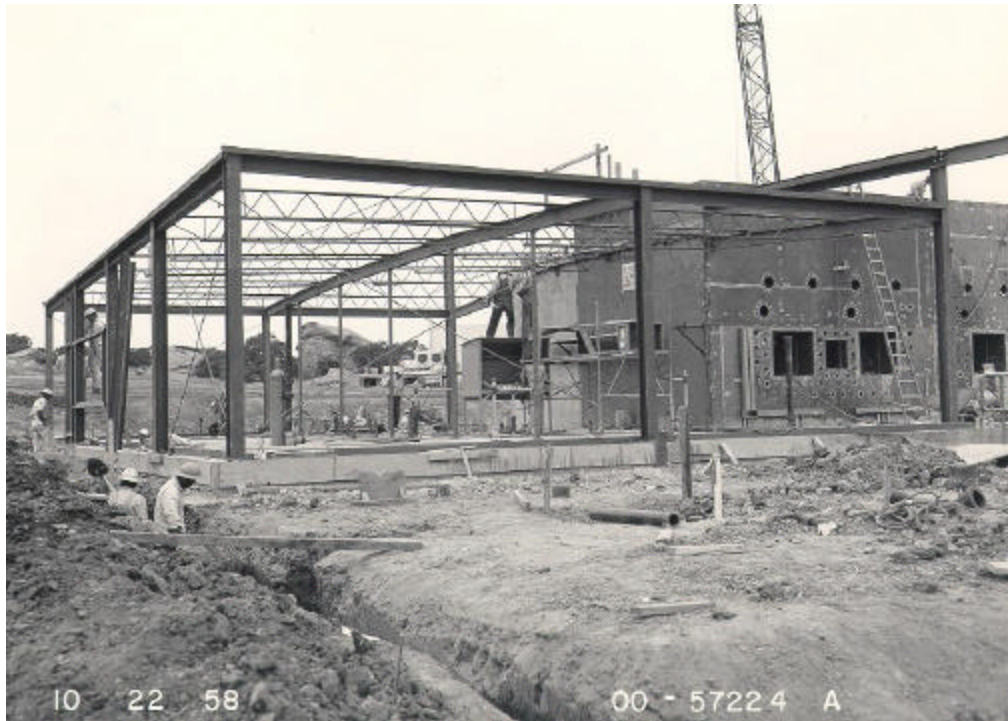
Figure 6-48. October 1958 Building 4020 Construction Photograph, Showing the Distinct Structures of the Steel Building and the Hot Cell/Decon Room Assemblies. [00-57224 10/22/58]

The success of previous concrete core drilling and sawing operations, plus follow-on discussions with contractor personnel, led to the decision to dismantle the concrete hot cells and decon rooms by saw-cutting the monoliths into manageable-sized blocks for subsequent decontamination at an on-site facility. Separate specifications were prepared for the dismantlement of the decon rooms and the hot cells. The strategy was to dismantle the normal-density concrete decon rooms first, identify any problems or potential areas of improvement, and incorporate the lessons-learned in the specification for the high-density concrete cell roof and walls. A third specification was prepared for the demolition of the steel building structure. The decon room demolition specification was released for bid in early January 1996.

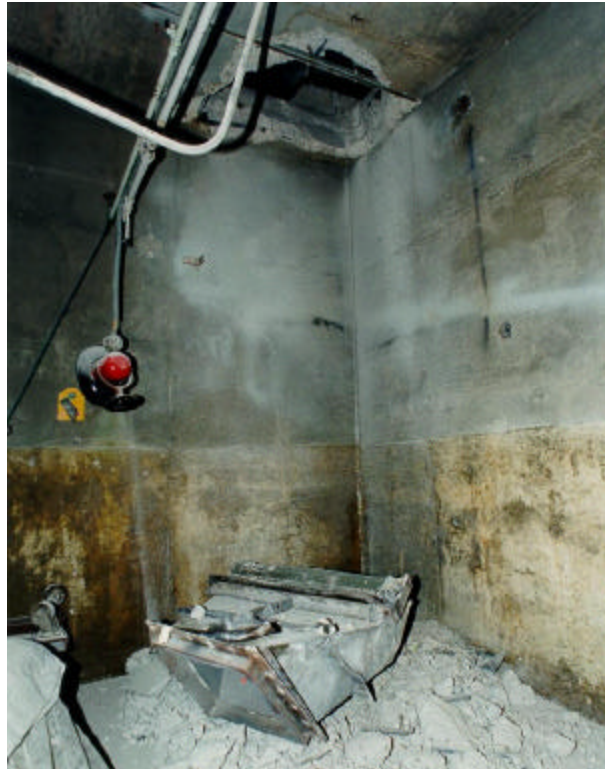
Figure 6-49. Removal of a Decon Room Exhaust Duct Riser (Basement View). [ETEC-2/8/96-394435]

The exhaust system from the decon rooms was deactivated and the ducting was removed. Portable units were installed to maintain proper air control in the work areas. The ducting was sectioned into pieces that could be handled by two mechanics, and each section was vacuumed as it was cut to remove loose contamination and to preclude re-contamination of cleaned areas.

Following duct removal, the risers into the decon rooms were removed using core drills and jackhammers to free them from the surrounding concrete, as depicted in Figure 6-49. The asbestos-gasketed sections were segregated, and all ducting was size-reduced, packaged, and transferred to the RMHF for final disposal.

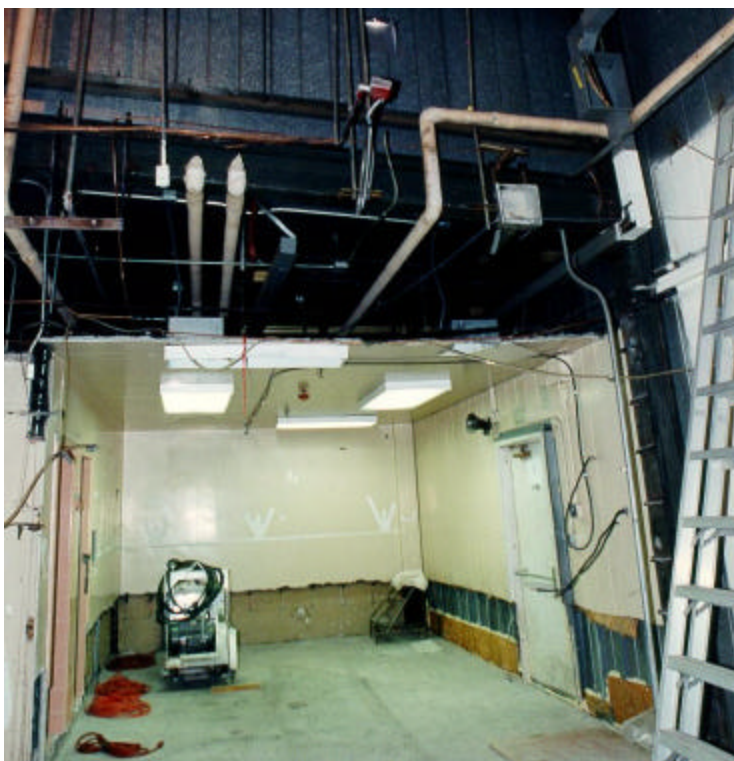
Figure 6-50. Hot Change Room Following Decontamination, Showing the Overhead Piping and the Removal of the Lower Portions of the Walls. [ETEC-3/1/96-394480]

Decontamination of the support areas continued. Work on the hot change room was completed, including scabbling of the concrete floor and removal of the lower 18 inches of the walls to provide access to contaminated areas, as shown in Figure 6-50. The interior walls adjacent to the service gallery were removed and replaced with a temporary barrier of plastic sheeting to improve access while maintaining air control. Decontamination and dismantlement work progressed generally clockwise around the facility from the service gallery. The inner walls and ceilings of the air lock, hot storage room, battery room, and mockup area were removed, as pictured in Figure 6-51. The few remaining light fixtures, the air conditioning ducts, and overhead piping (Figure 6-50) were removed and temporary portable lighting was installed. All of the overhead piping systems were vacuumed and wet-wiped prior to cutting and removal to minimize the spread of residual contamination. The facility air compressors and boiler systems were removed from the heating/ventilation and equipment rooms. That equipment was cleaned, released, and recycled where possible. The large facility air conditioning plenum was found to be contaminated. It was lowered to the floor, size-reduced, and cleaned for free release.

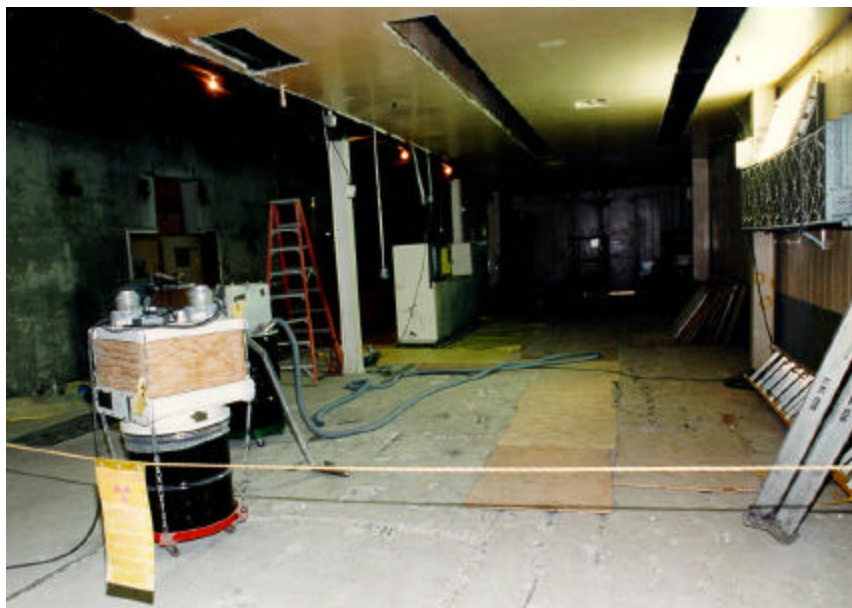
Figure 6-51. View from the Battery Room Toward the Airlock with Interior Walls Removed. The Service Gallery Is to the Left of the Posts. [ETEC-3/1/96-394486]

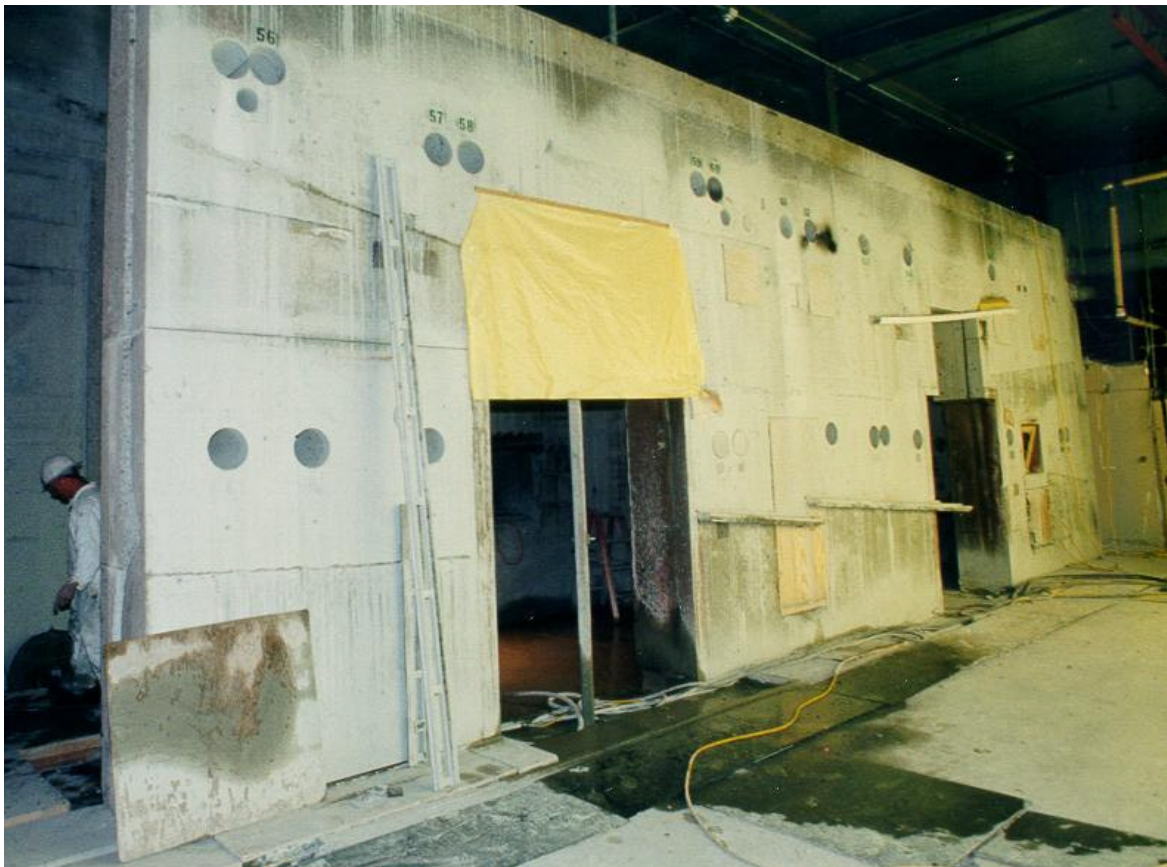
Figure 6-52. Core-Drilled Decon Room Walls for Forklift Access. [ETEC-5/24/96-394571]

A contractor was selected for the demolition of the decon rooms and demolition work was initiated in March 1996. The decon rooms were constructed of standard reinforced concrete with 24-inch-thick walls and 12-inch-thick ceilings. The contractor was responsible for preparing the blocks prior to cutting for handling and for cutting the blocks to maximum weights of 10,000 pounds each. Handling preparations included core drilling holes in the walls, as shown in Figure 6-52, to allow a forklift to remove cut wall sections by inserting its forks into the holes (Figure 6-53). A large concrete saw with diamond-tipped blades was used to make the cuts (Figure 6-54), and the final cut was made with the forklift holding the weight of the block. A special-purpose fixture was designed and fitted to a large-capacity forklift to support the ceiling blocks during cutting and to handle them after the cuts were complete. The removal of a ceiling block using this fixture is illustrated in Figure 6-55.

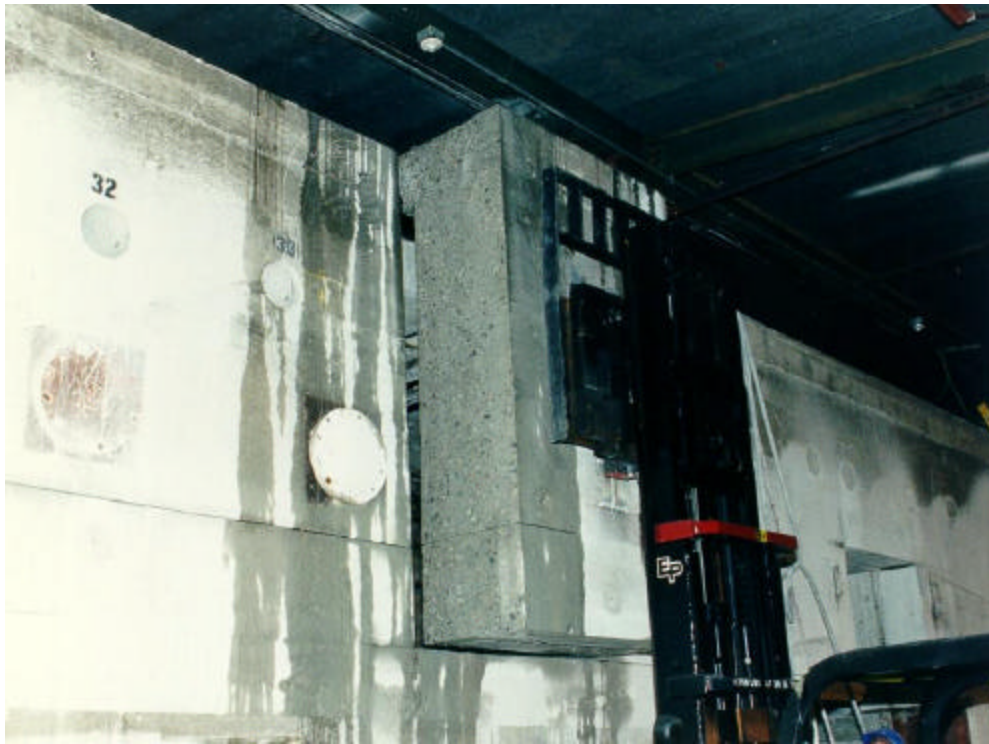
Figure 6-53. Forklift Removal of a Concrete Decon Room Wall Block. [ETEC-4/26/96-394546]

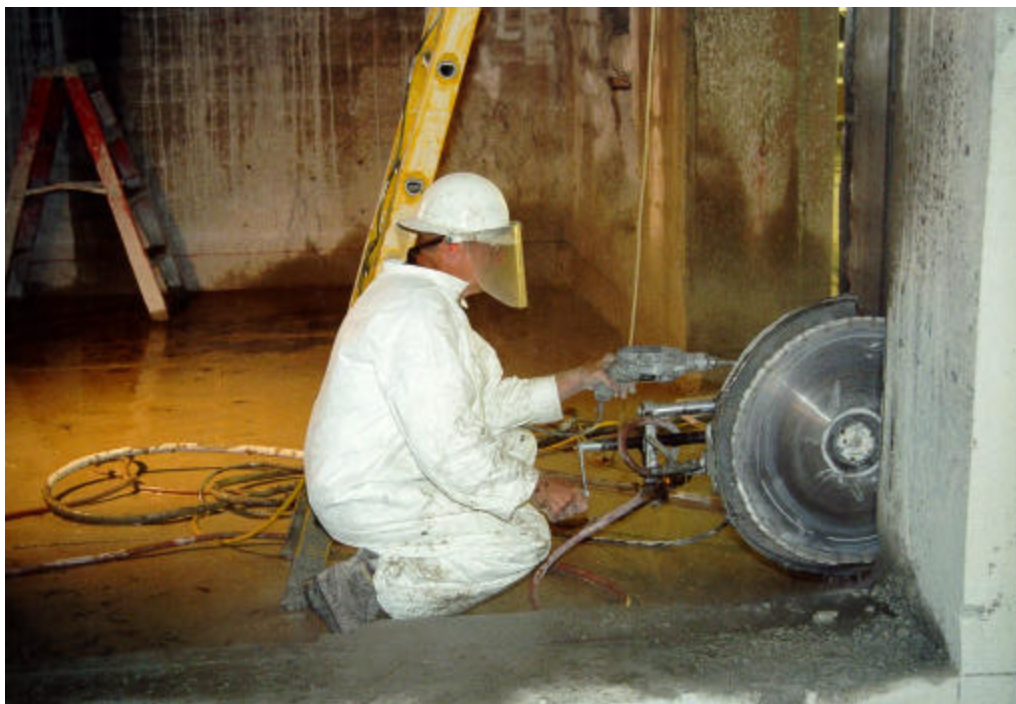
Figure 6-54. Saw Cutting of the Decon Room Concrete Walls. [ETEC-5/24/96-394587]

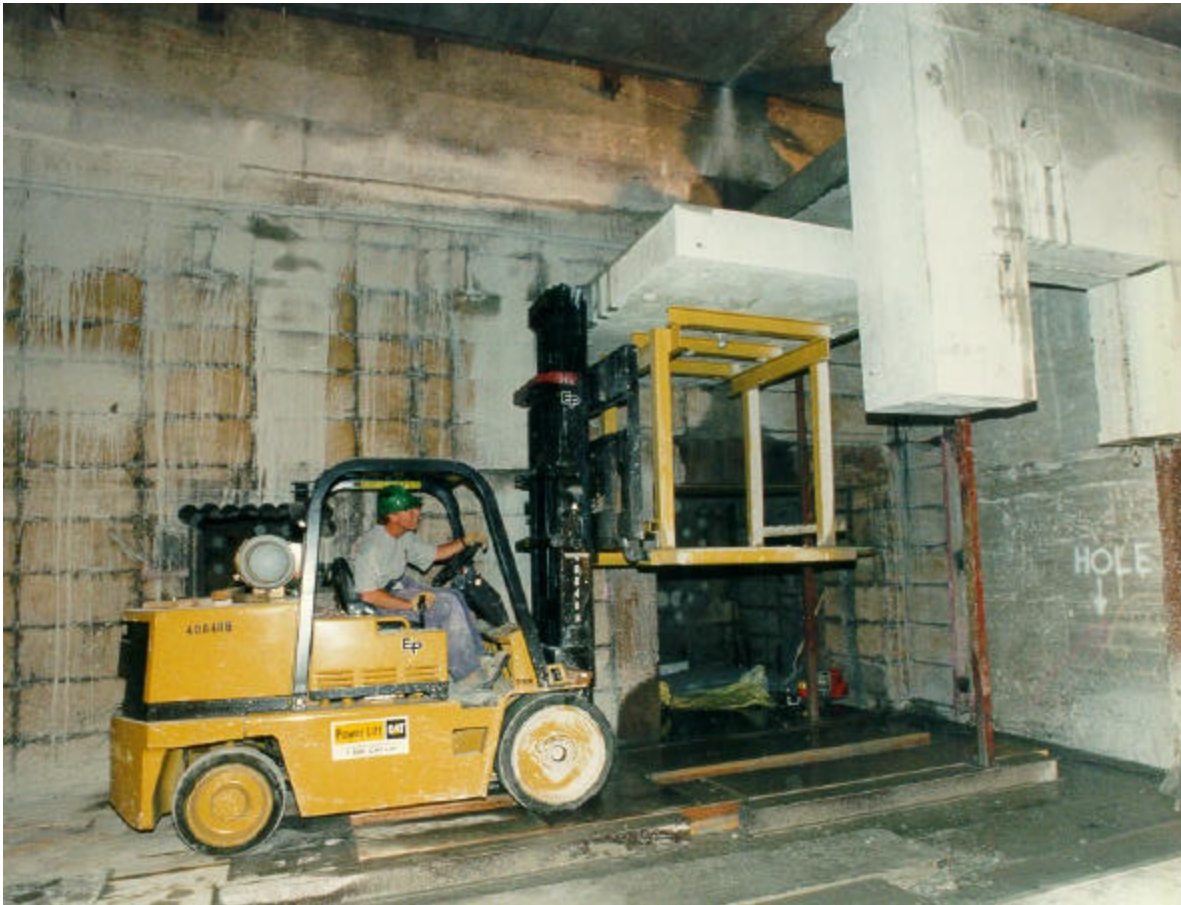
**Figure 6-55. Removal of a Decon Room Ceiling Block
Using a Special-Purpose Fixture.** [ETEC-4/19/96-394537]

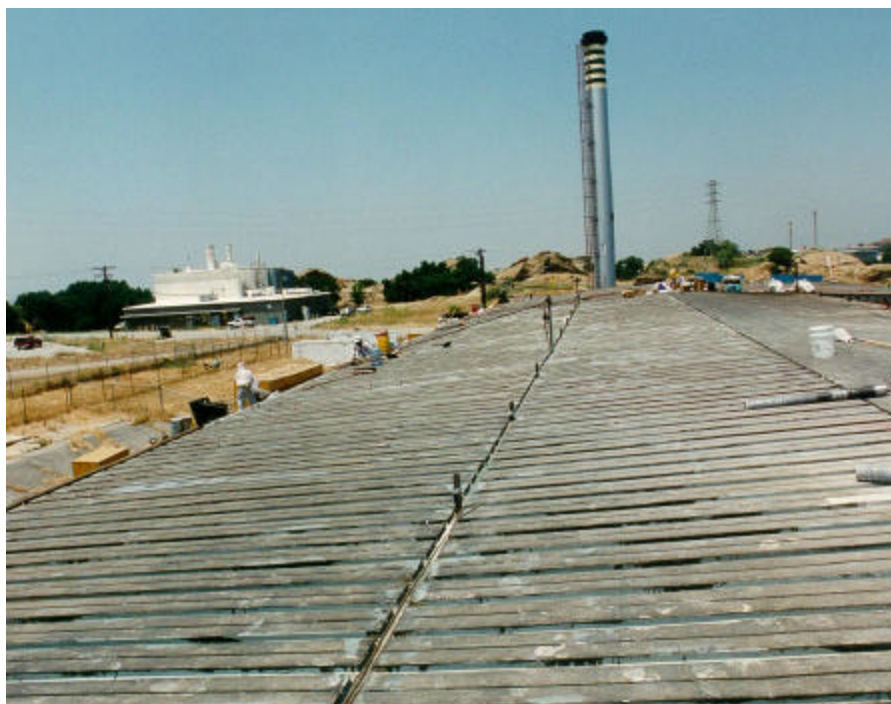
Figure 6-56. Removal of the Building 4020 Overlying Metal Roof. [ETEC-6/13/96-394599]

Demolition of the decon rooms was followed by the removal of the Building 4020 roof. The building had been re-roofed several times, and its roof consisted of several layers of asphalt and gravel beneath a metal covering. Core samples were taken from eight locations and volumetrically analyzed for radioactivity using a Canberra HPGe radiation detector. The results showed trace levels of contamination, which could have originated from the combination of trace building stack emissions over a thirty-year operational period and atmospheric fallout associated with past world-wide nuclear weapons testing. The samples were also analyzed for asbestos, which was found in the felt layers. The entire roof was removed by an outside asbestos abatement contractor and placed in enclosed 15-yard gondolas. The gondolas were transferred to the RMHF pending disposal at an authorized off-site location as asbestos-containing radioactive waste. Roof removal activities are shown in Figure 6-56 (metal covering) and Figure 6-57 (underlying asbestos-containing asphalt)

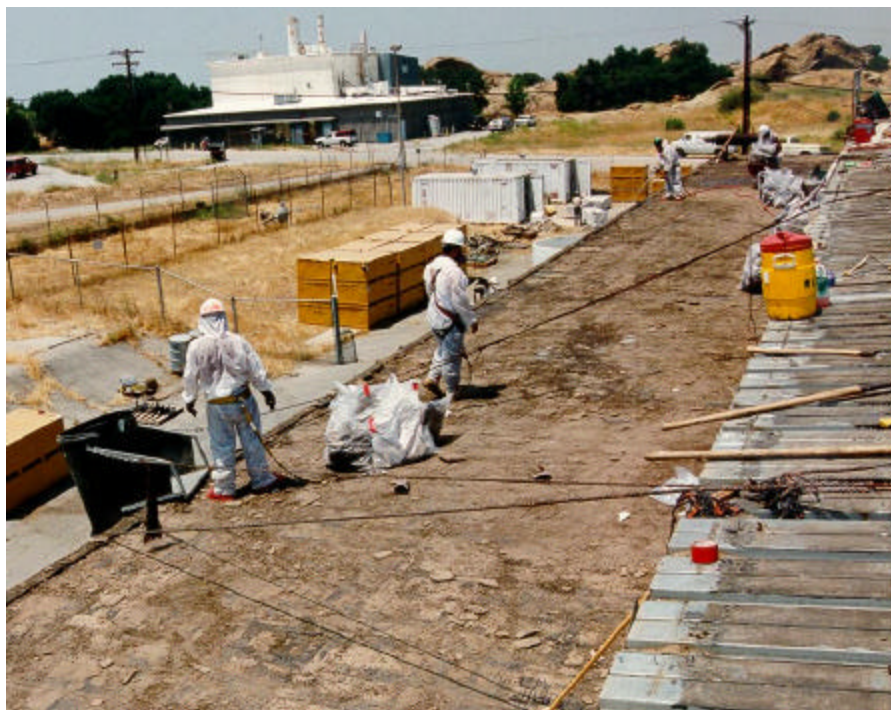
Figure 6-57. Removal of the Building 4020 Underlying Asbestos-Containing Asphalt Roof. [ETEC-6/13/96-394598]

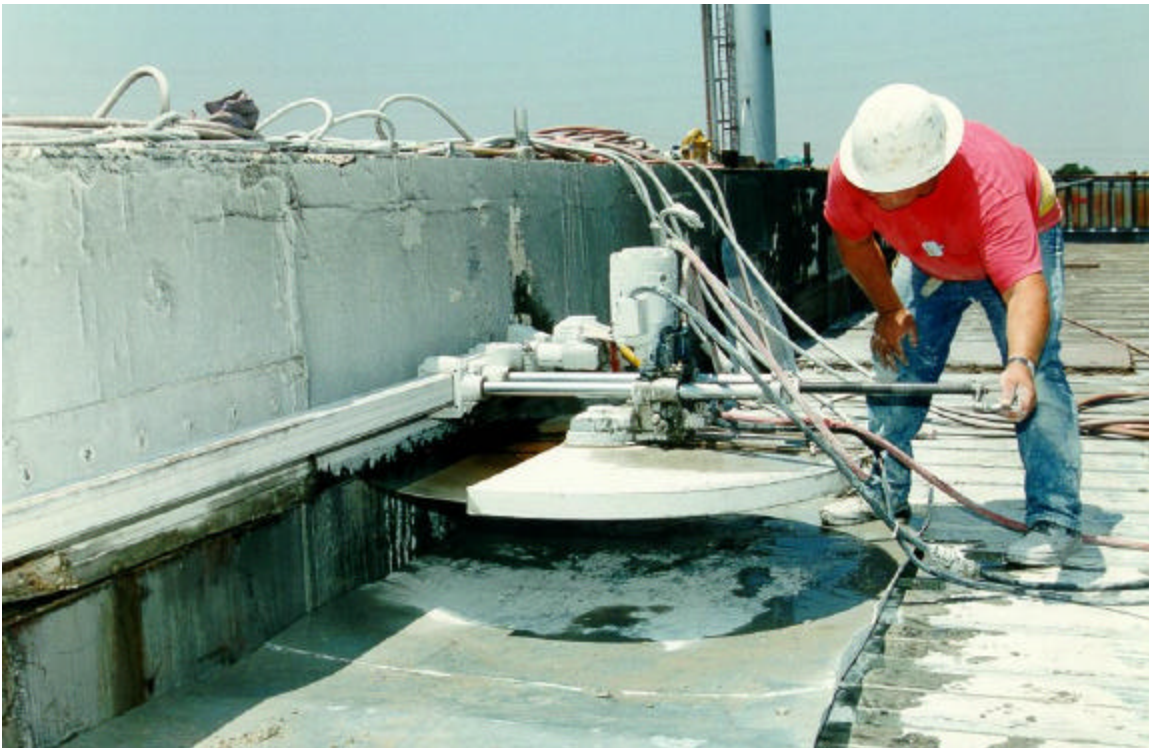
Figure 6-60. Detachment of the Cell Roof Block Segments by Saw Cutting. [ETEC-6/13/96-394591]

The cell roof was sectioned into blocks by core drilling. This process, pictured in Figure 6-58, was used to perforate the roof into sections, as shown in Figure 6-59. Core drilling was selected over saw cutting because it was considered to be as efficient as saw cutting for this application and eliminated the dangers associated with performing overhead cutting operations. Saw cutting would have required cuts from both the top and underside of the roof because of limitations in the saw-blade diameter. Concurrent with the core drilling, horizontal cuts were made at the tops of the walls from the outside to detach the roof blocks from the walls (Figure 6-60). The cut depths were just short of penetrating the full wall thickness. Jacks were then used to detach the roof blocks, which were removed by overhead crane (Figure 6-61).

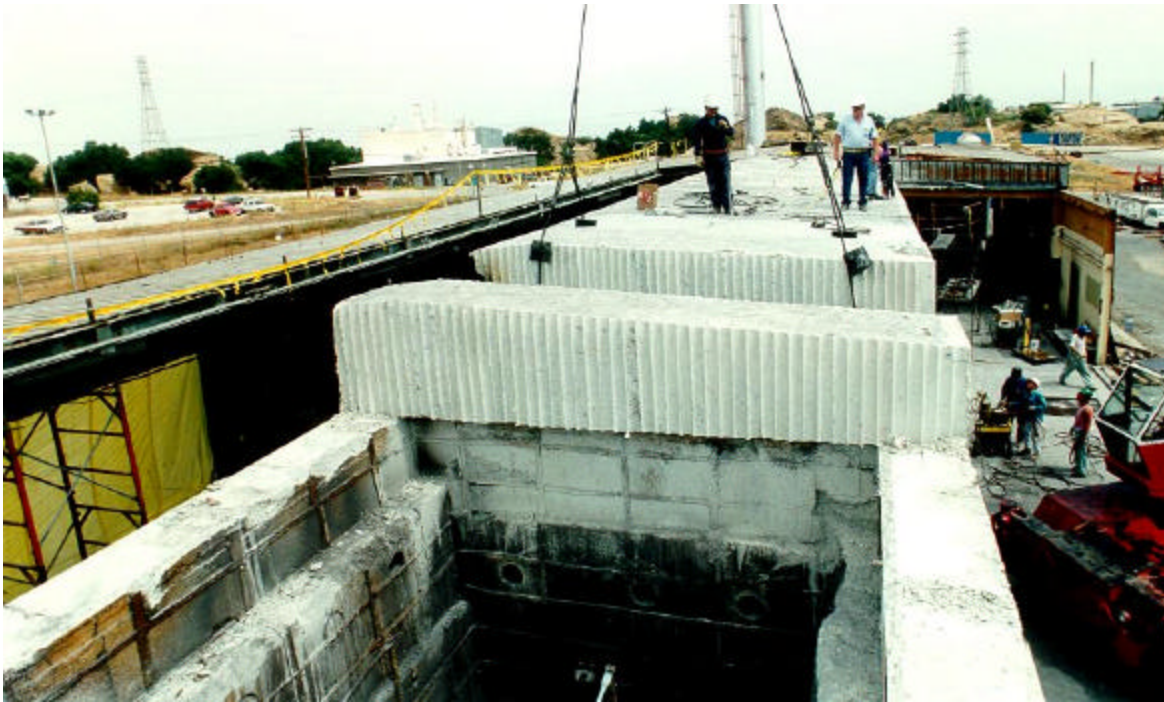
Figure 6-61. Removal of the Concrete Cell Roof Blocks. [ETEC-6/25/96-394638]

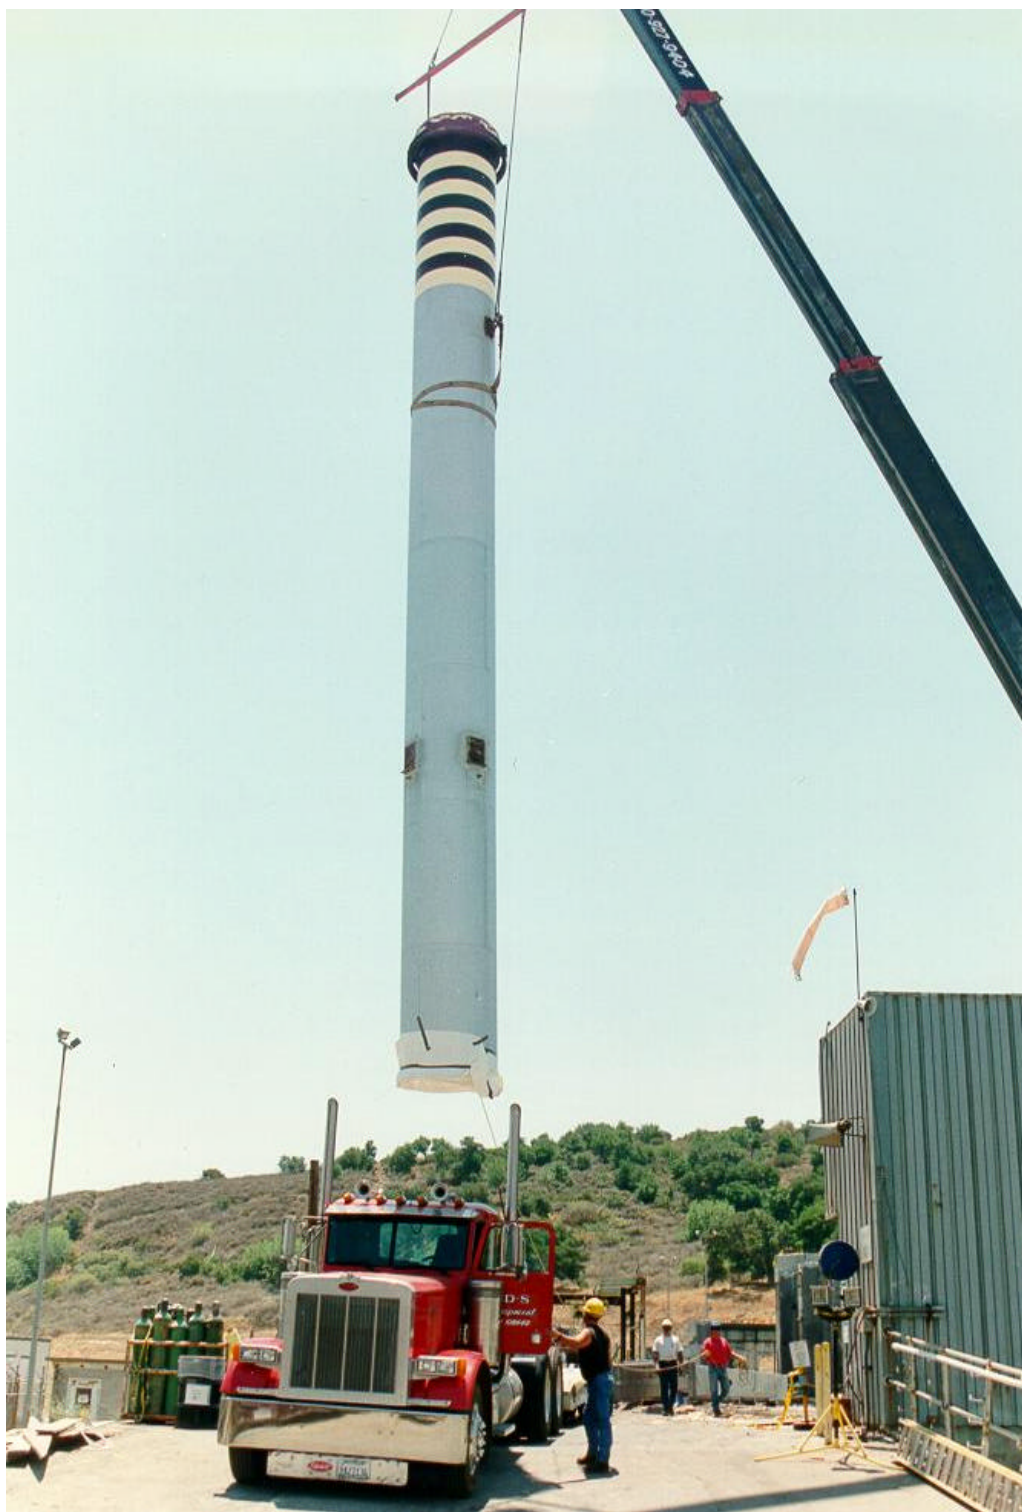
Figure 6-62. Removal of the Top 55 Feet of the Building 4020 Exhaust Stack to a Flatbed Truck for Transport to the RMHF. [ETEC-9/9/96-394817]

The top 55-foot section of the 75-foot-high building exhaust stack was also removed by the contractor. The stack was supported by a crane and severed several feet above ground level. The ends were sealed and the severed section lowered to a flatbed truck (Figure 6-62) for transport to the RMHF for size-reduction and packaging for disposal. The remaining 20-foot section was left in place pending shutdown of the basement exhaust system. Concurrent with the removal of the upper stack, the facility general HEPA exhaust system was shut down and replaced with two 4000-cfm portable HEPA systems to support basement decontamination. Openings in the floor (basement roof) were covered with plywood and sealed to control air flow within the basement. Basement decontamination control was maintained by partitioning the area into small sections that were serviced by supplemental 1000-cfm portable HEPA systems.

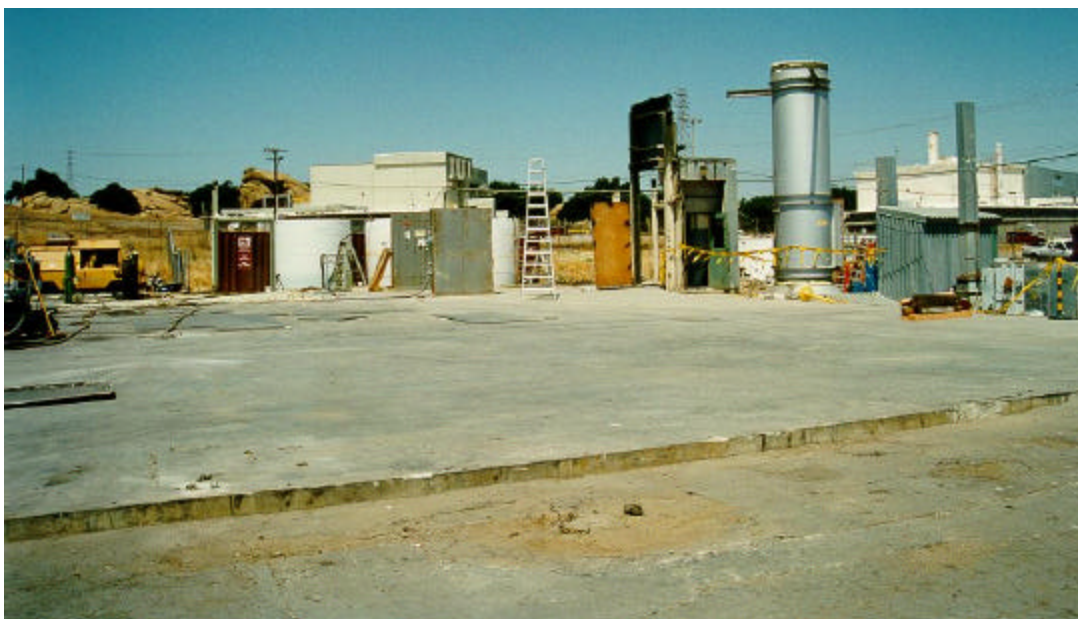
Figure 6-63. Cleared Building 4020 Floor Slab and Remaining Exhaust Stack Section. [ETEC-8/6/96-394760]

Following completion of the contractor work, all remaining concrete rubble was packaged for disposal, including all of the cores generated by cell roof core drilling. The building slab was then swept and washed down to eliminate any potential for contamination spread by wind-blown dust from the structure demolition. Figure 6-63 shows the cleared slab and the remaining portion of the exhaust stack, and Figure 6-64 is a photograph of the Hot Laboratory site from above in November 1996.

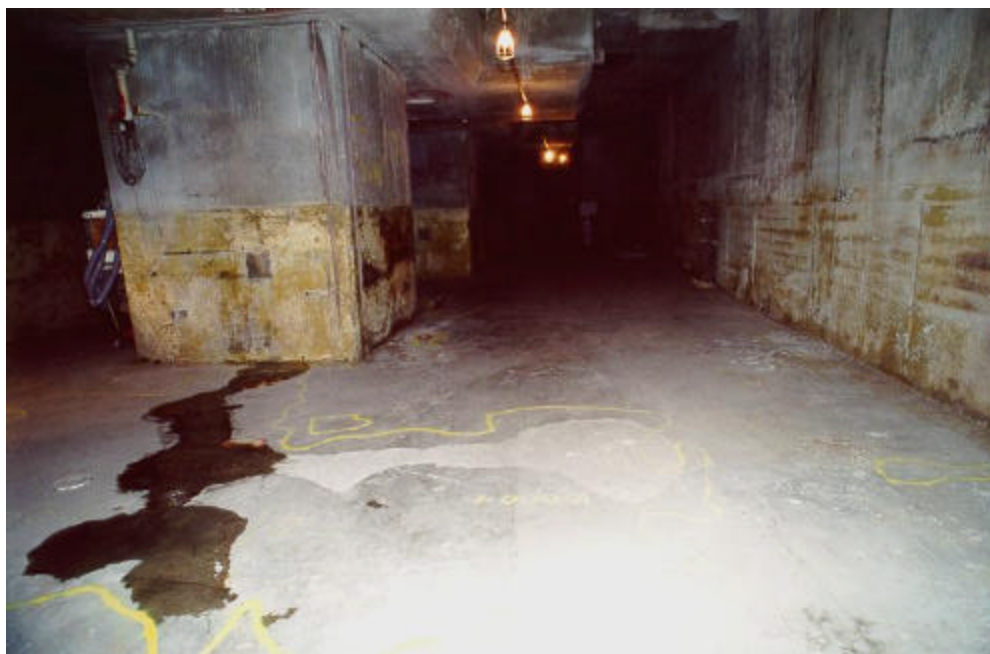
Figure 6-65. Basement Area During Survey Mapping for Hot Spots. [ETEC-11/11/96-394952]

Removal of the HEPA ventilation system provided access to the underlying floor area for decontamination. The decontamination was performed using a commercial pneumatic floor scabbler that incorporated four hammer heads and had a concrete floor scabbling rate of about 1 ft² per minute. The scabbling operations concentrated on historically known hot spots, including specific floor sections and areas around sumps and drain openings. The basement floor in the general area depicted in Figure 6-65 before scabbling is shown after scabbling in Figure 6-70.

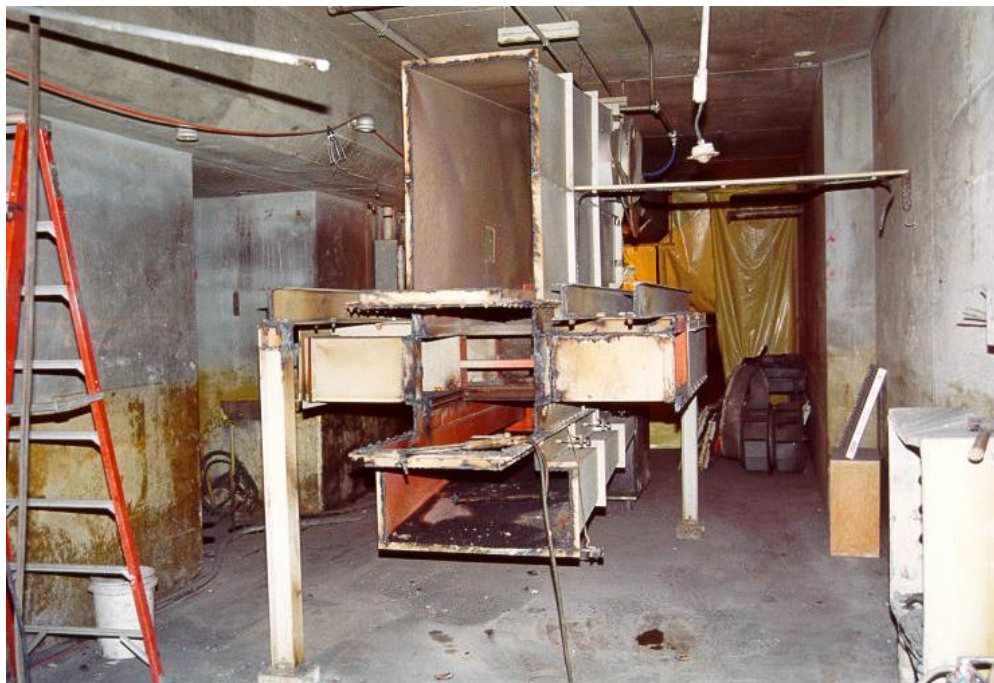
Figure 6-66. Basement HEPA System Plenum and Ducting During Removal. [ETEC-10/2/96-394902]

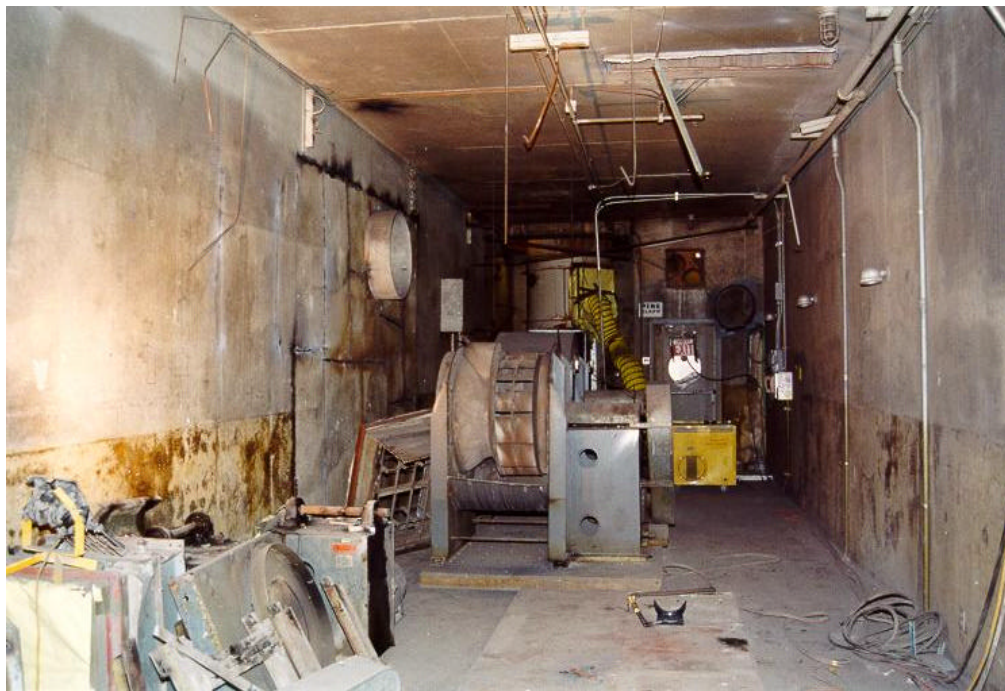
Figure 6-67. Basement HEPA System Blower During Removal. [ETEC-10/2/96-394903]

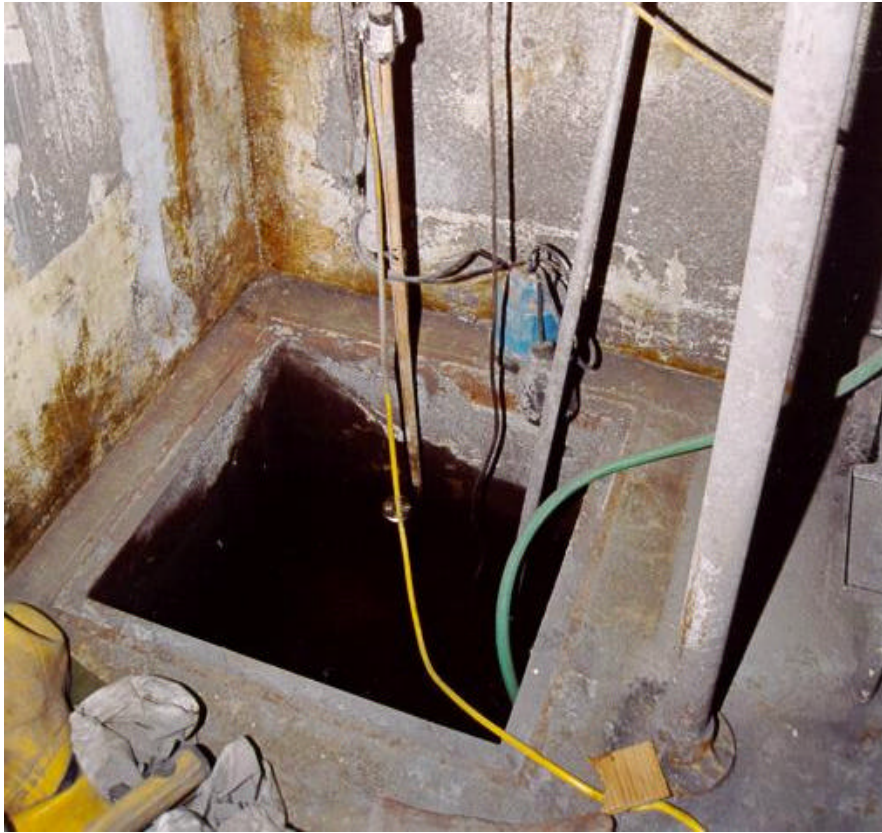
Figure 6-68. Basement South Sump Prior to Cleaning. [ETEC-10/2/96-394922]

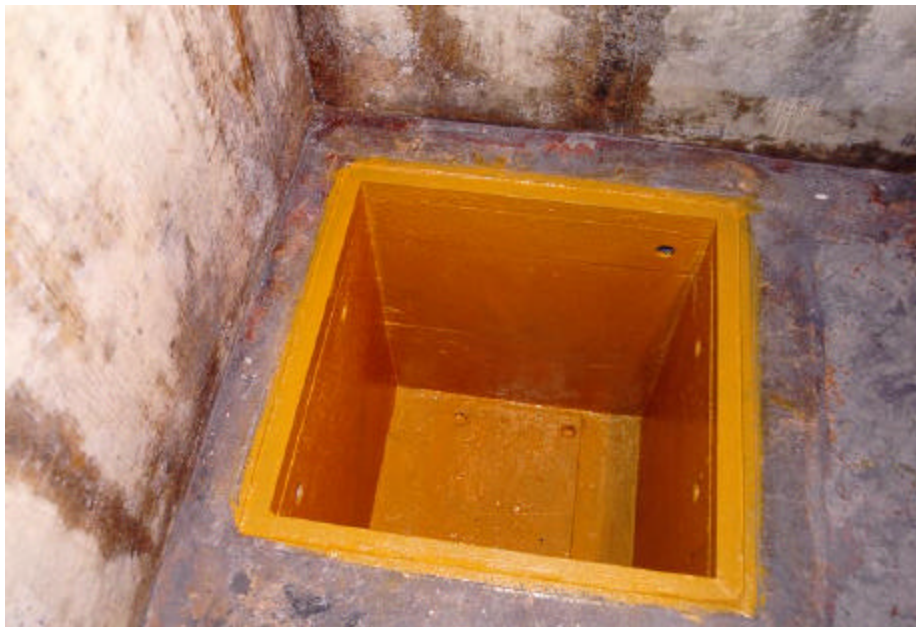
Figure 6-69. Basement South Sump Following Cleaning and Painting. [ETEC-12/20/96-394967]

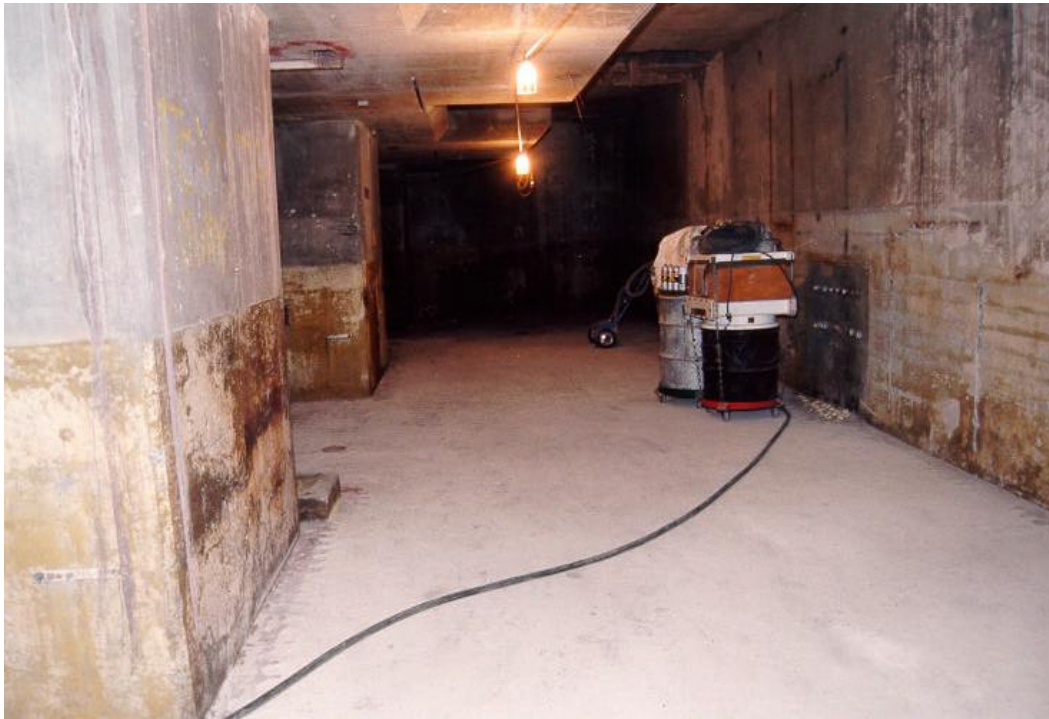
Figure 6-70. Basement Floor Following Scabbling. [ETEC-12/20/96-394965]

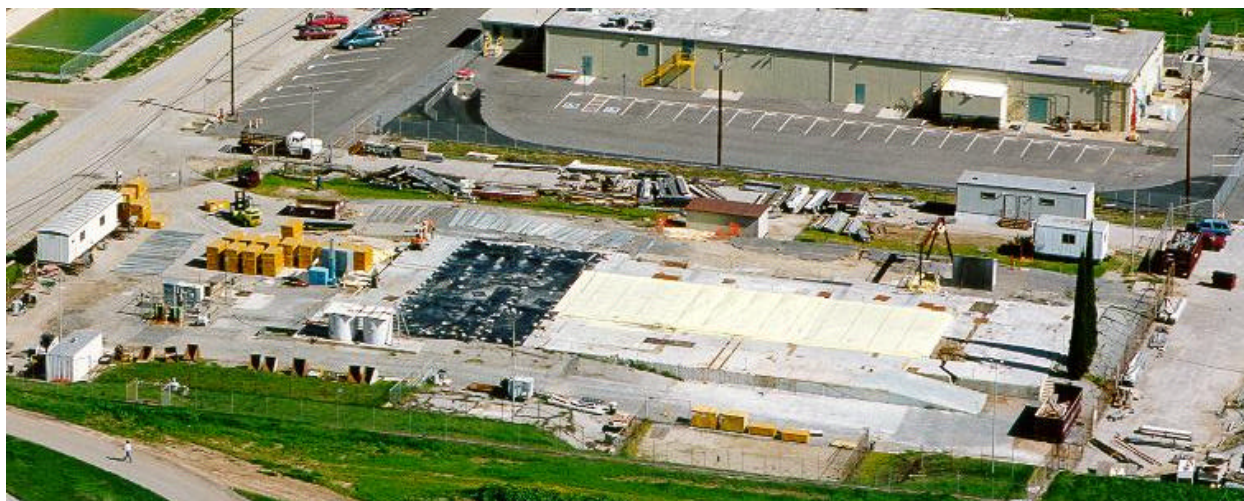
Figure 6-72. Basement Covering to Minimize Water Influx During the Rainy Season. [ETEC-97/02/14-394989]

The removal of the HEPA ducting and other support systems left numerous openings in the basement roof. Projected El Niño storms during the 1996-97 fall and winter raised concerns of heavy rainfall and the subsequent generation of large quantities of contaminated water in the basement. A wooden structure approximately 25 feet wide by 100 feet long was constructed to cover the basement during the rainy season. The structure was sloped and covered with plastic to divert rainwater to site drainage channels. Extra waste water storage capacity was set up using portable double-wall tanks. Even with the cover, approximately 6,500 gallons of rain water were pumped from the basement in the December – February period. The external rain-protection covering is shown in Figure 6-72.

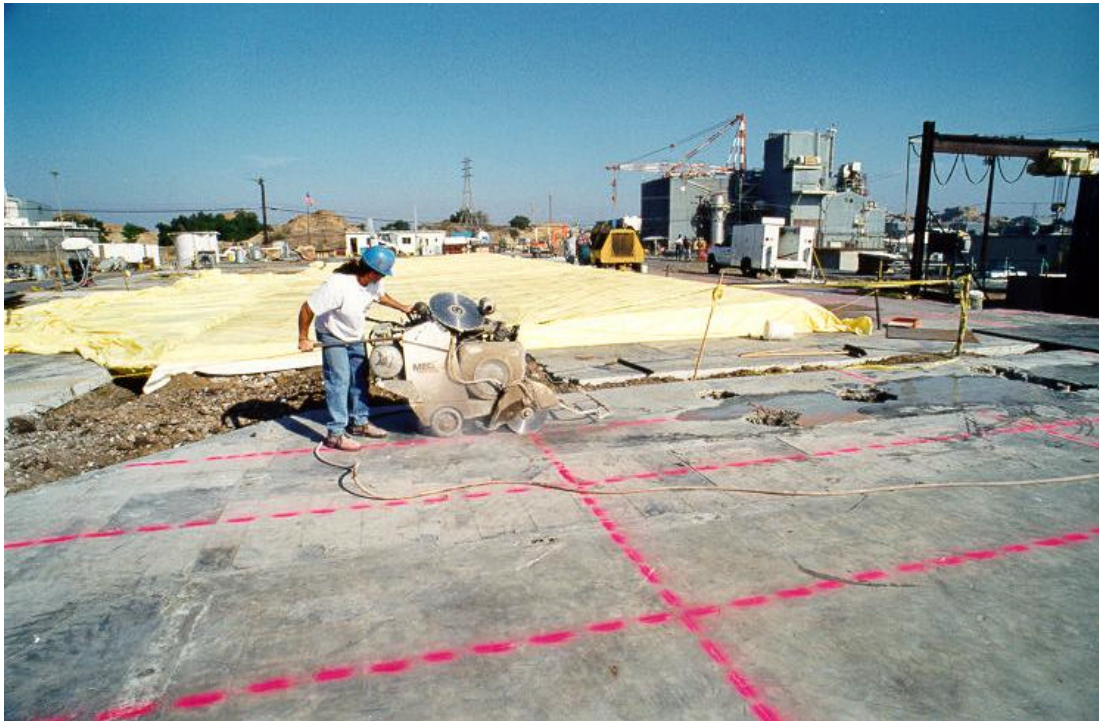
***Figure 6-73. Saw-Cutting of the Building 4020 Slab
Adjacent to the Covered Basement.*** [ETEC-11/11/96-394945]

A contractor was selected at the beginning of FY 1997 to section the basement concrete structure (roof, walls, and floor) by saw-cutting and to handle and transfer the resulting concrete slabs to designated storage areas. That work was initiated in November 1996, beginning with the floor slab of the former office and support areas, which were outside of the basement area. This floor slab cutting operation is shown in Figure 6-73, where the covered basement roof is visible in the background.

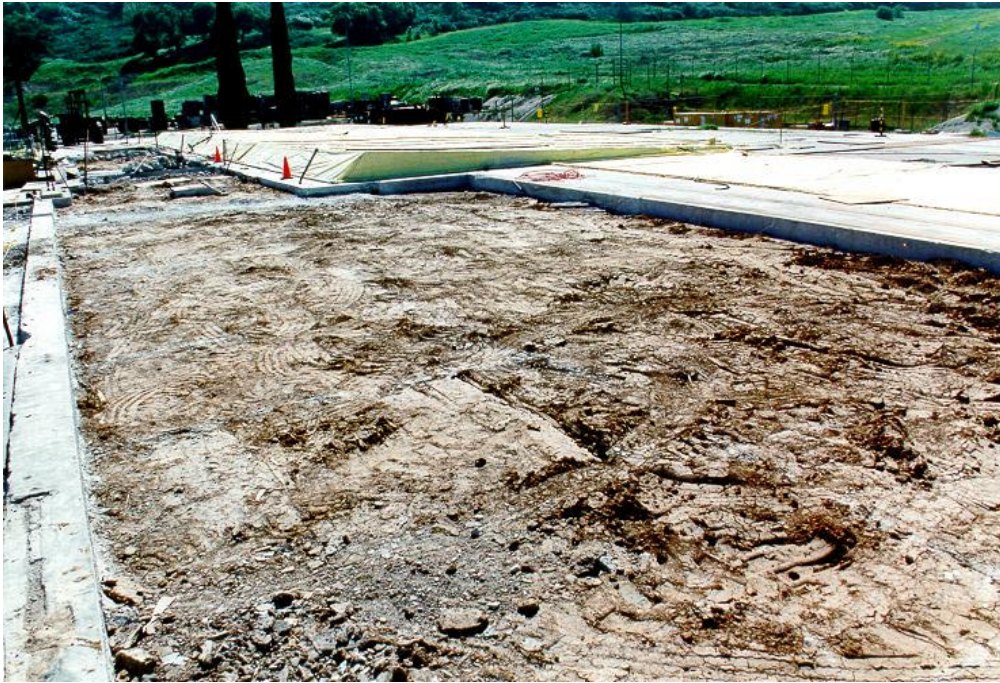
Figure 6-74. Soil Exposed by Concrete Pad Removal. [ETEC-4/19/97-395065]

Following the rainy season, the contractor removed, numbered, and stacked the cut slab sections in the south parking lot of the facility. A large excavator was used to move the slabs to the storage area for later survey and disposition. The exposed soil (Figure 6-74) was surveyed, and any detectable contamination was removed to eliminate the potential for spread of contamination. At the same time as the slab was being removed, contractor crews inside the basement put up scaffolding to support the basement roof area. That scaffolding, for which an example is shown in Figure 6-75, was used later to support the roof sections when they were cut.

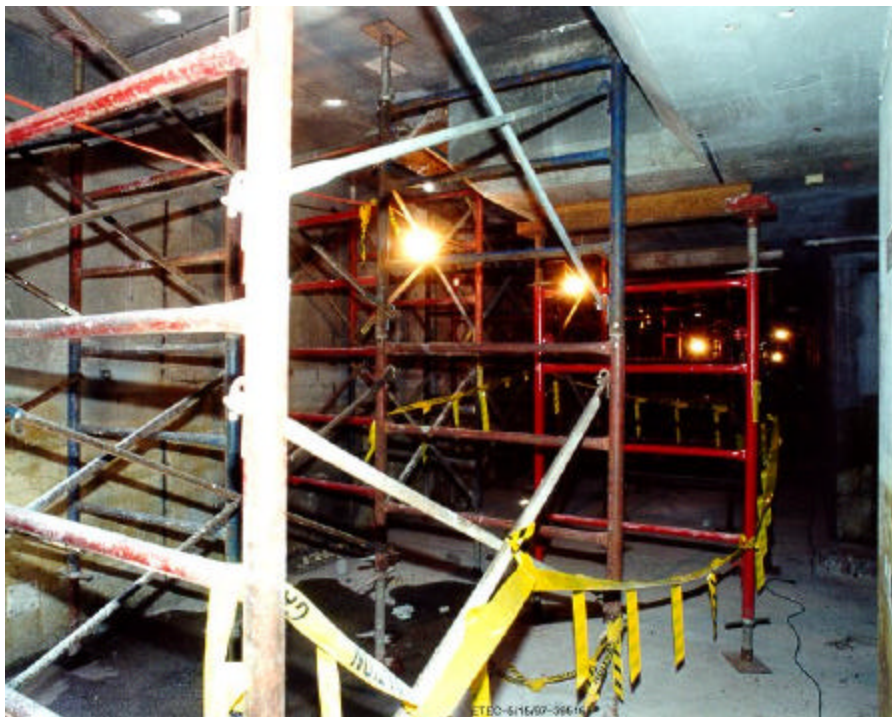
Figure 6-75. Basement Scaffolding Used to Support the Roof During Cutting. [ETEC-5/15/97-395165]

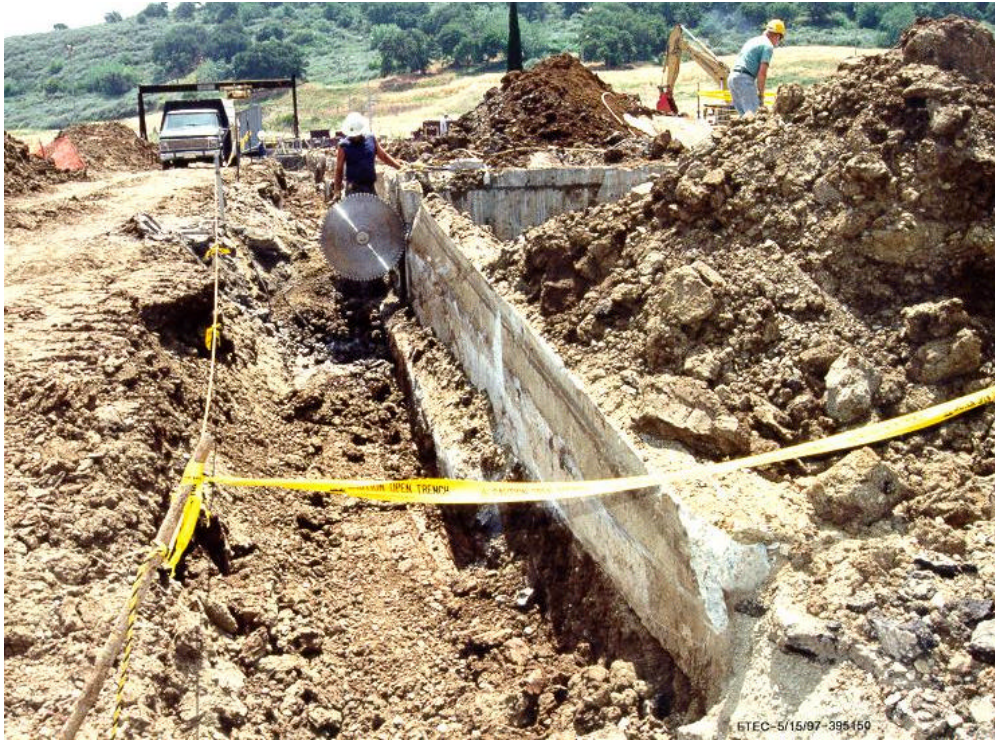
Figure 6-76. Sectioning of the East Foundation by Saw Cutting. [EIDEC-5/15/97-395150]

Once the concrete floor slabs that had surrounded the basement area were removed, the contractor was able to begin excavation around the support foundation walls that supported the steel frame of Building 4020. That work started at the northeast corner of the facility and worked toward the south along the eastern support foundation wall. Figure 6-76 shows the sectioning of the east foundation by saw cutting.
